Fukushima Daiichi NPS: Cracks in Foundation Concrete in H-4 and H-4 East Tank Areas

February 12, 2014

Tokyo Electric Power Company

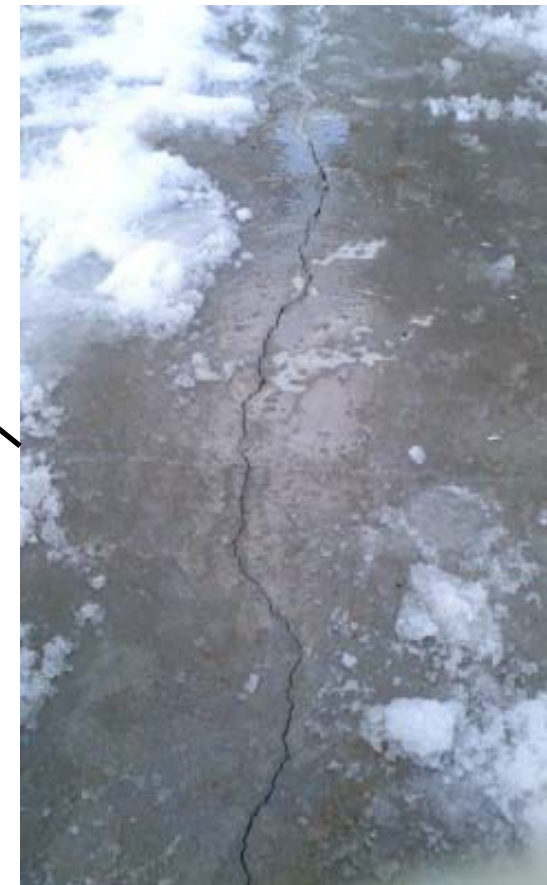
H-4 East area

- <H-4> Approx. 12m in length
 - <H-4 East> Approx. 8m in length
 - There was no water accumulated in each of these cracks when it was found.
- Time course of the finding of cracks

- **The waterproofing capability has been proved effective for the cracks found this time.**
 - After leakage from tanks in August 2013, application of urethane coating was planned as a construction for permanently waterproofing the inside of the dikes also in the areas found to have cracks this time. **When concrete surface cleaning was conducted** as preparatory work for the construction, **the cracks became clearly visible.**

- Soil recovery around the areas will be conducted as a precautionary measure.
- A thorough inspection for cracked conditions will be conducted in the areas where application of urethane coating has not been completed yet.
- Application of urethane coating on the inside of the dikes is currently underway as a fundamental measure for joints and concrete cracks, and has been expedited to be completed as early as possible.
 - Implementation of this measure was completed in the H5 area.
 - Implementation of this measure is underway in the H4 and H4 East areas. (Gap-filling between tank components and the foundations is nearly completed. We expect that the coating application will be completed in late February.)
