Reactor imaging technology for fuel debris detection by cosmic ray muon

Measurement status report in Unit-1

March 19, 2015

Tokyo Electric Power Company

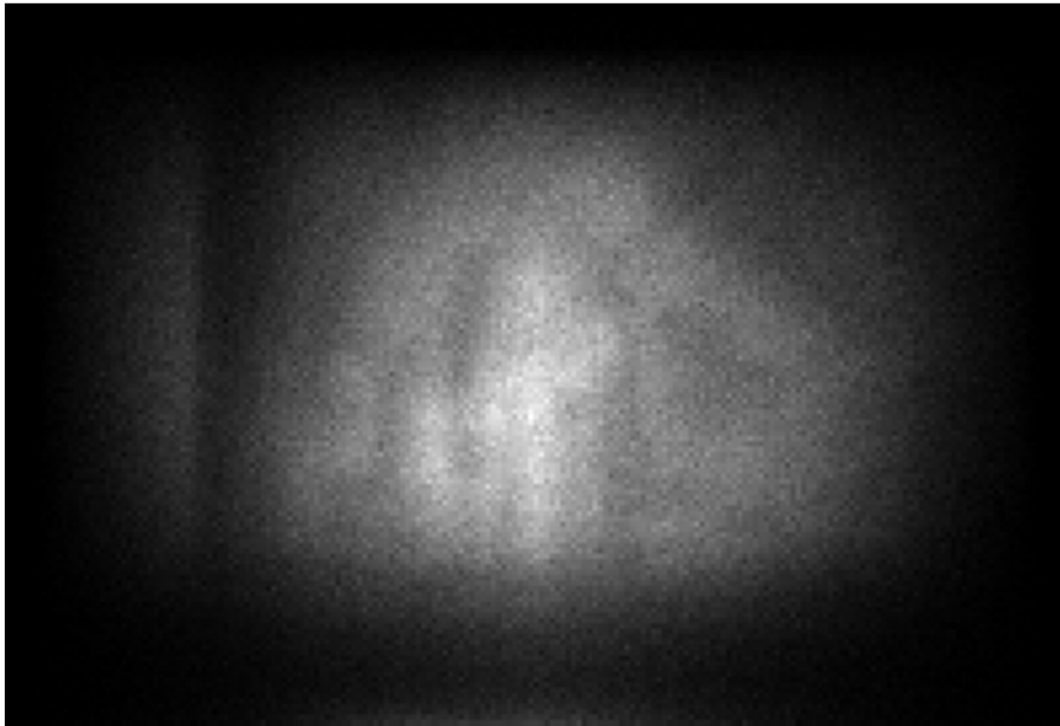
Photo 2 : Taken by detector-1 (NW side)

- Some structure and equipment edges were distinguished, although the data shown were not so detailed as that created by design drawing

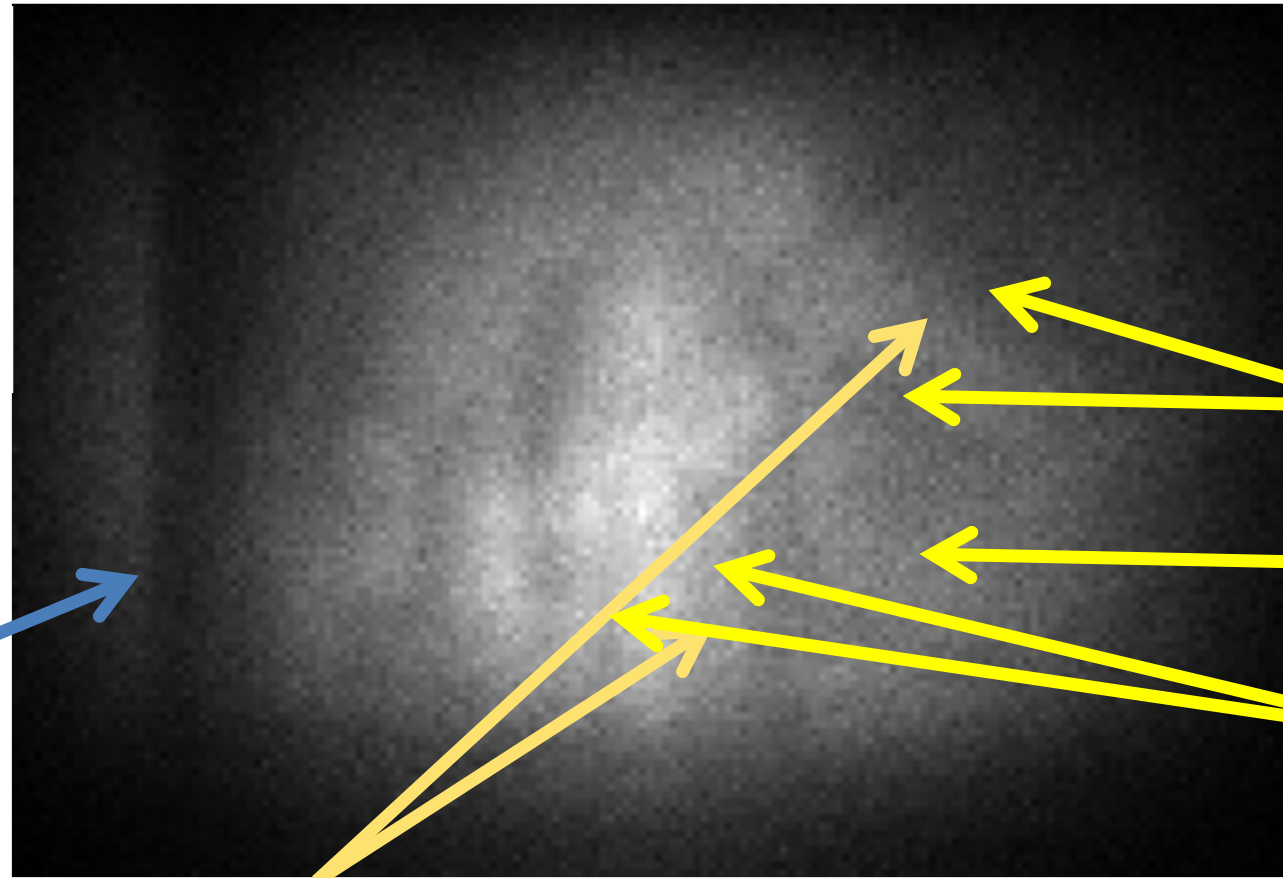
Photo : Measurement result taken by detector-1 and the interpretation

Structure edge can be identified clearly, however high-density lump can not be distinguished inside RPV

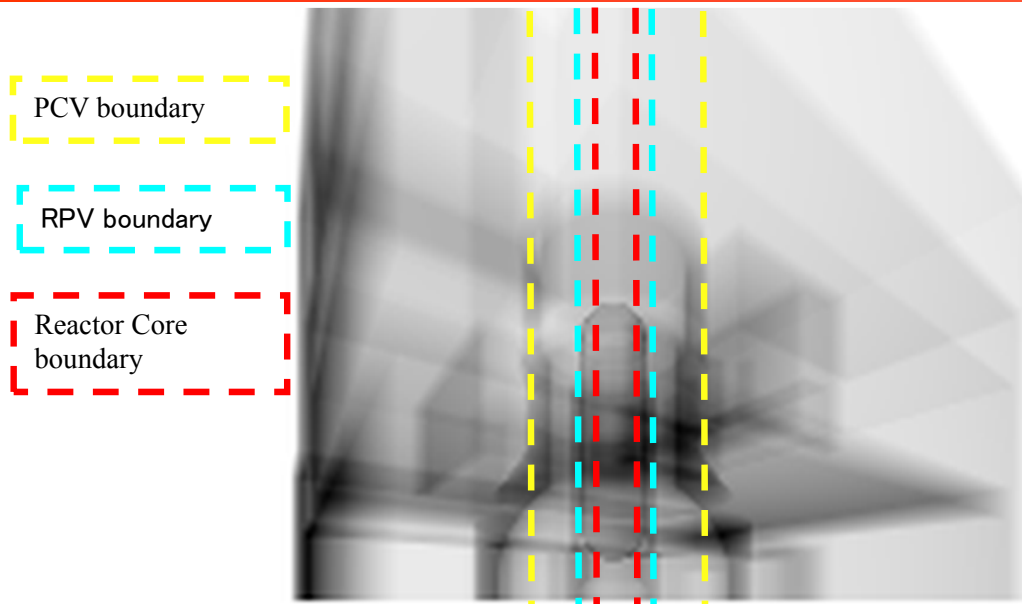
6. Estimated position of debris by comparing design drawings with measured image (detector-1)

- Although the image of the measurement data is not so clear, it shows that the PCV, the RPV and the core are in positions where they should be.
- In addition, the boundaries of the PCV and RPV on the design drawings match those on the measurement data.
- However, the measurement data do not show the existence of high-density substances (fuels) in the original position of the reactor core.

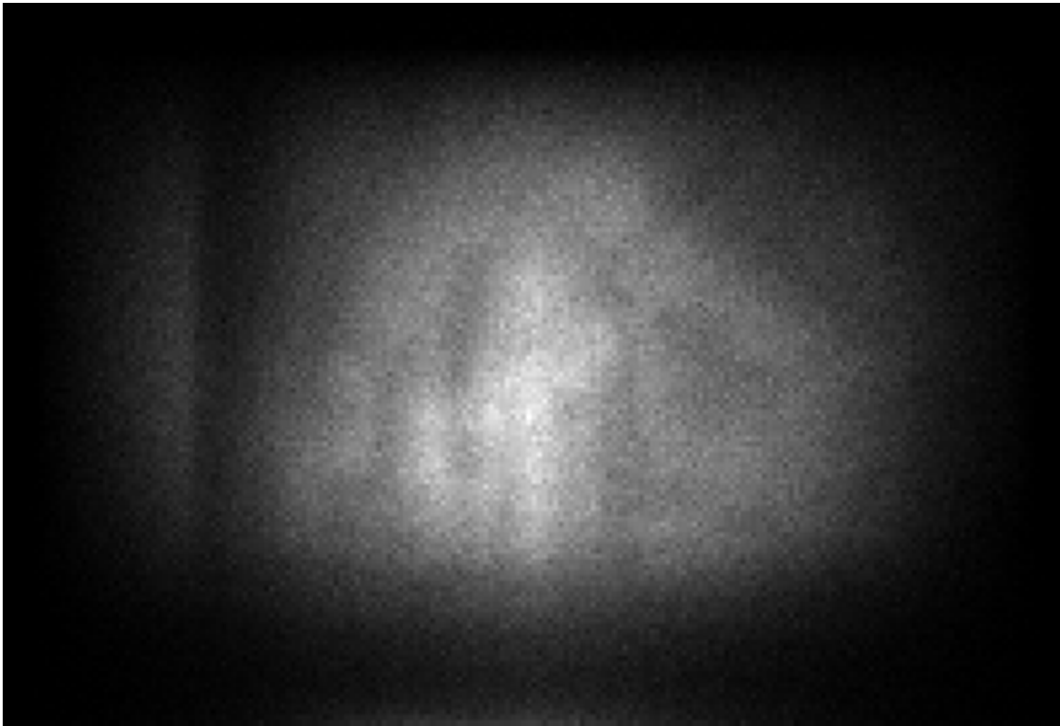
Figure 2. Measured image from the detector 1 (North west side)

The results gained from the detector 1 (North West side) do not identify fuel debris inside the reactor, while those from the detector 2 (North side) appear to show something exists inside.

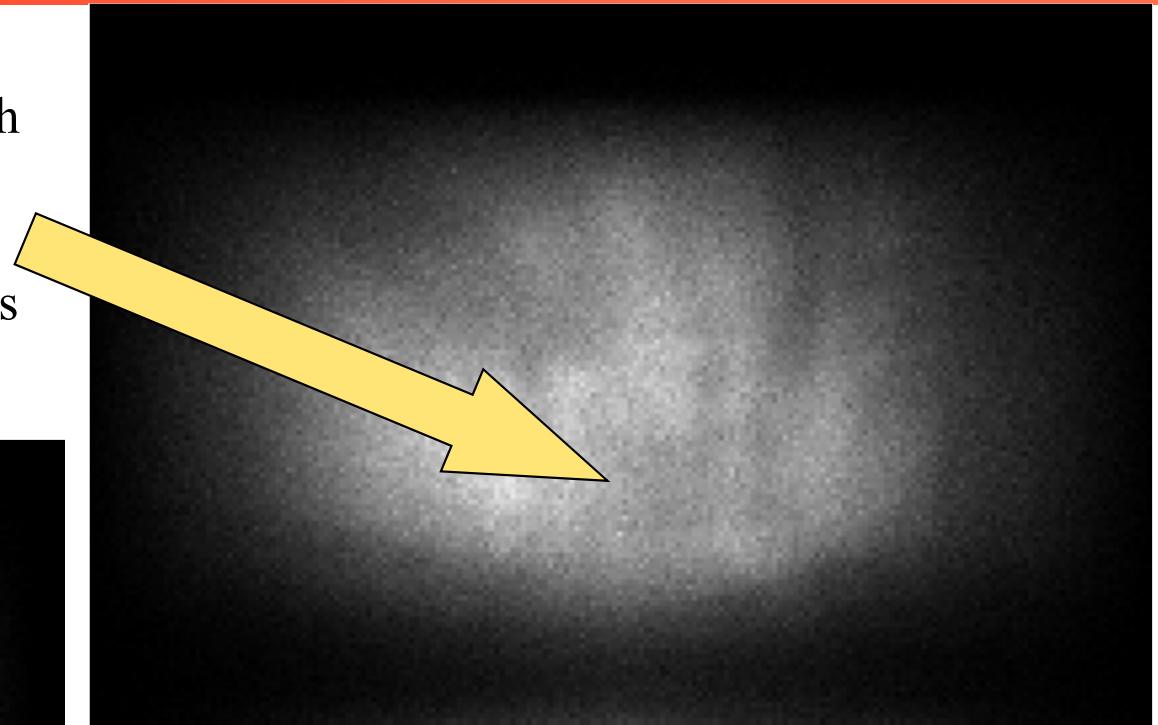
Figure 1. Measured image from the detector 2 (North side)

The position of the black objects on the data measured by the detector 2 (north side) will be estimated by three-dimensionally assessing them.

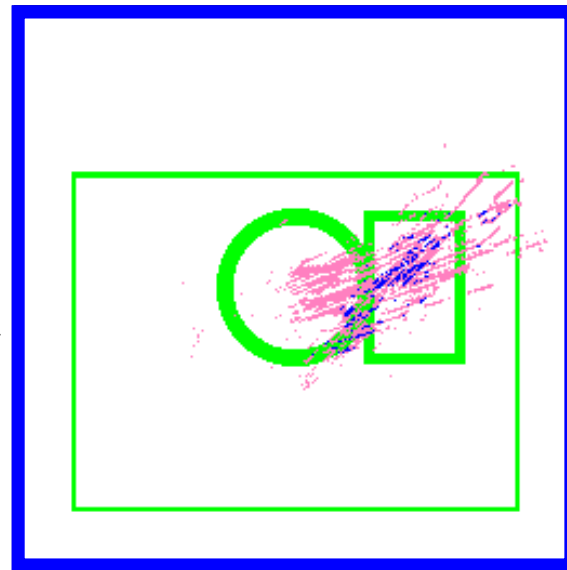
Figure 3. Evaluation of the cross section of the SFP floor
Some intersections (South side of Bldg, Corresponding to SFP)

- Through the 3D evaluation, it has been estimated that there is fuel in the SFP. (How big they are will be calculated later.)
- These results agree with the TEPCO's estimation of the current core and PCV status.

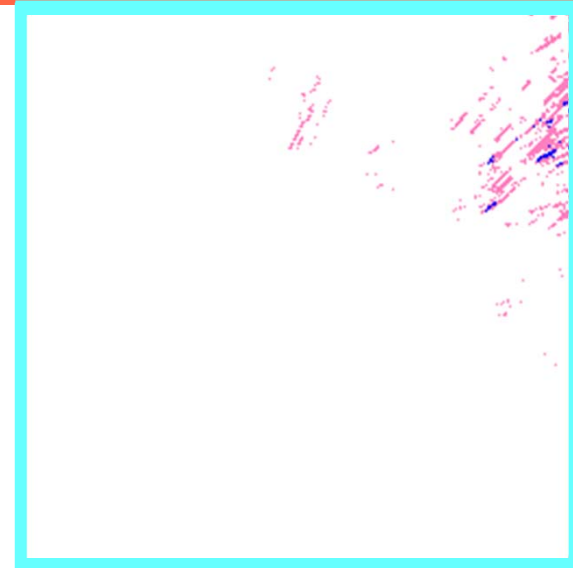
Figure 4. Evaluation of the cross section of the operating floor
No intersections (some noise detected)

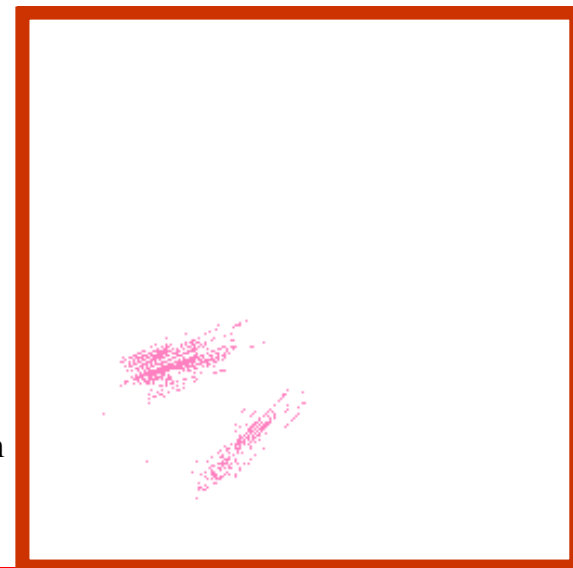
Figure 2. Evaluation of the cross section of the core
No intersections

- On the other hand, current data shows no large fuel debris of more than 1m in the original core position.
 - There is a strong possibility that there is no water accumulated in the core area of RPV. (Reference: it was assumed through the water level gage calibration in May of 2011 that there was no water accumulated in the core area.)
