# Fukushima Daiichi Nuclear Power Station - Causes for the reduction in the water level of the outer dike in H4 area and related countermeasures

March 19, 2015

The Tokyo Electric Power Company, Inc.

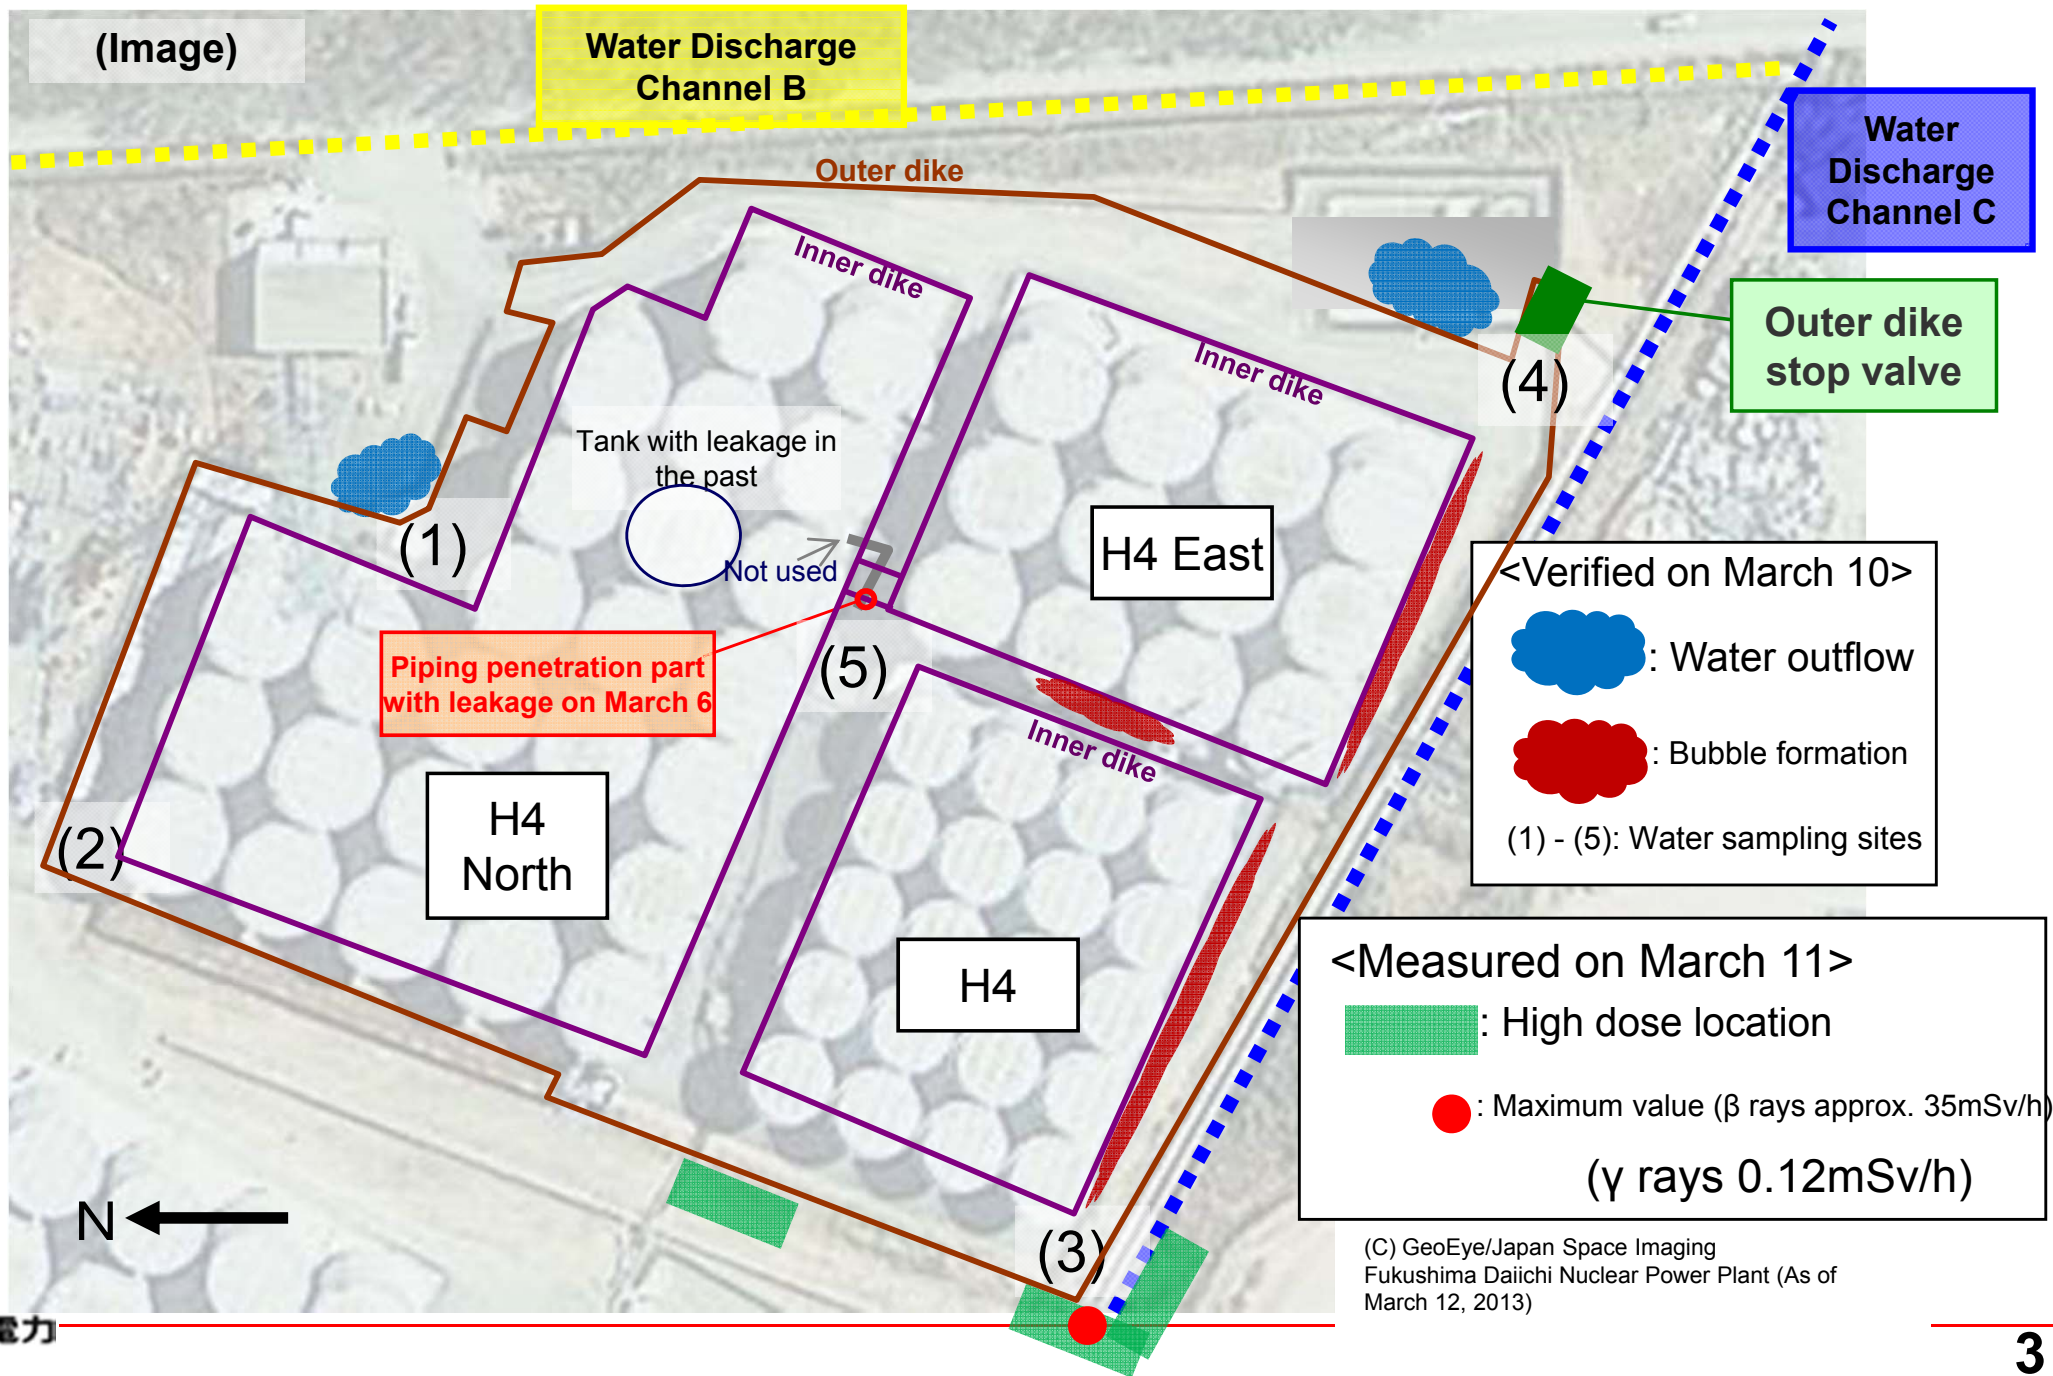
# 1. Overview (Reference: Conditions in the Field)

- Around 22:30 on March 9, 2015, it was confirmed that the water level of the outer dike in H4 area had become approximately 15cm due to rainfall.
- When the water level was checked in the field, it was confirmed that the water level had dropped to approximately 10cm at around 6:24 on March 10.

- When the surrounding conditions were checked, it was confirmed that the water was flowing out from the eastern outer dike of H4 east and H4 north areas and air bubbles were coming out from the joints of the foundation area and the gutter between the inner dike and outer dike.

Water sampling site (Water sampling time)	(1)(9:10)	(2)(9:15)	(3)(9:20)	(4)(9:25)	(5)(9:30)
Total beta [Bq/L]	1,900	1,500	8,300	150	370
Cesium 134 [Bq/L]	ND(11)	ND(10)	ND(12)	ND(10)	ND(11)
Cesium 137 [Bq/L]	18	ND(17)	ND(16)	ND(16)	ND(17)

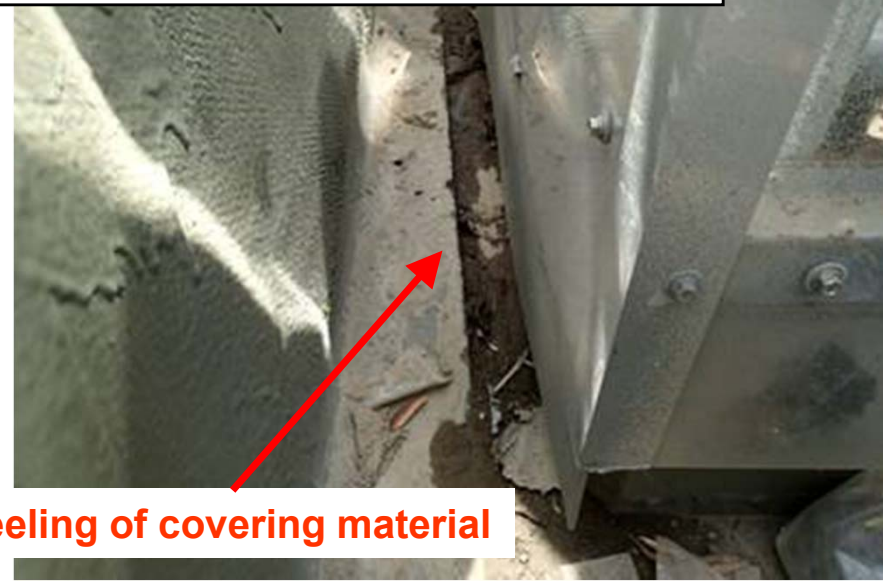
### H 4 North-east side earth-fill dam

- Partial peeling of the covering material of the earth-fill dam was noticed at the location where there was leakage from the earth-fill dam on the east side of H4 North.
- Gaps have been formed between the gutter and the surrounding mortar on the side of the gutter on the south side of H4 and it is assumed that there is seepage into the ground from these gaps.
- Further, it is inferred that the air that is accumulated in the crushed stones beneath the tank foundation is escaping from the gaps due to which air bubbles are being forming from the side of the gutter.

Peeling of covering material

- 1) Making the necessary fixes with respect to the peeling of the covering material and formation of bubbles from the gaps in the gutters (completed on March 16)
- 2) Inspection and maintenance of the covering material and the gaps in the gutters in the H4 area dike
- 3) Covering the entire inner surface of the outer dike to prevent recontamination (spraying)

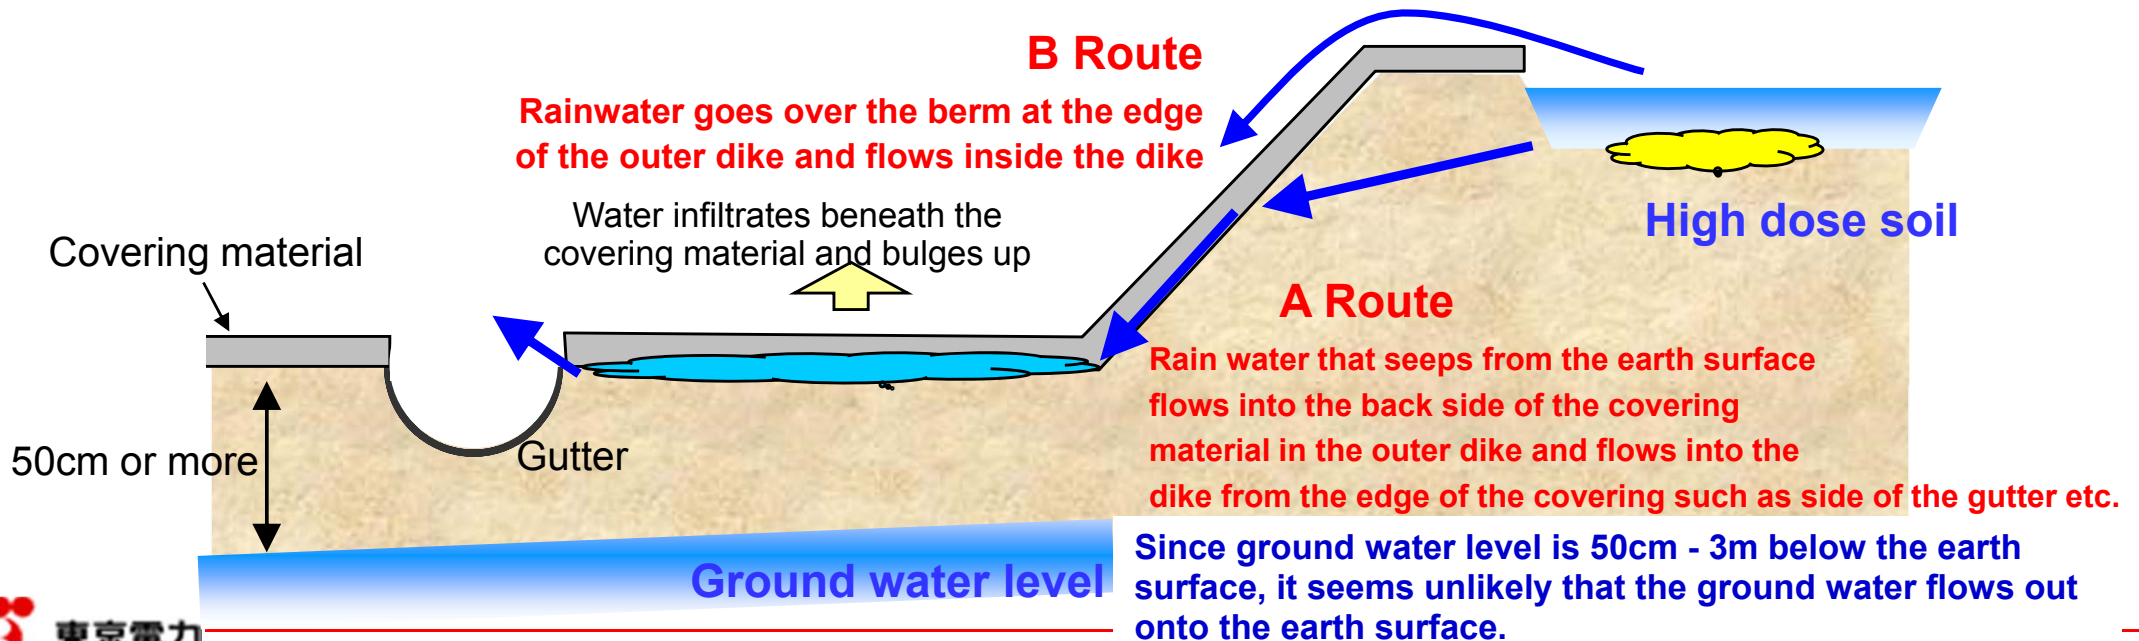
### Reason why total $\beta$ radioactivity (8,300Bq/L) is high in Location (3)

- It was confirmed that the high dose soil is distributed in 2 locations on the elevated area on the west side of outer dike in H4 area. These are the locations where there had been leakage from the concentrated water transfer pipe in March 2012.

- It is very likely that rain water that had come in contact with the contaminated soil during rainfall flowed into the dike via the route specified below and contaminated the water in the dike.

- A. Rain water that seeps from the earth surface flows into the back side of the covering material in the outer dike and flows into the dike from the edge of the covering such as side of the gutter etc.

- B. Rainwater goes over the berm at the edge of the outer dike and flows inside the dike.
- Further, both Location (1) (1,900Bq/L) and Location (2) (1,500Bq/L) are locations that were contaminated due to leakage of H4 tank in August, 2013 and leakage from the concentrated water transfer pipe in March 2012 respectively.

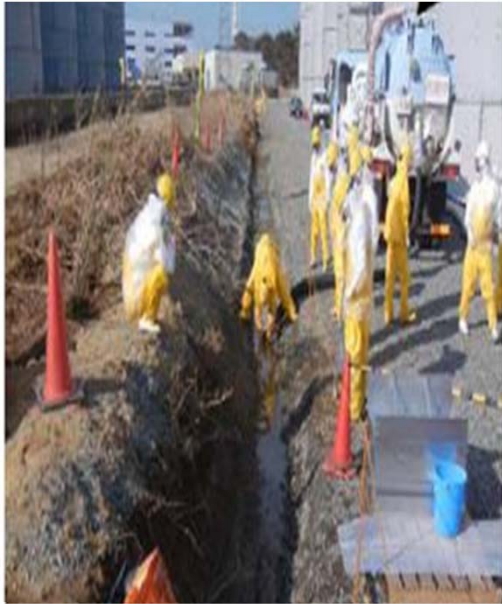
(1)

Contaminated soil

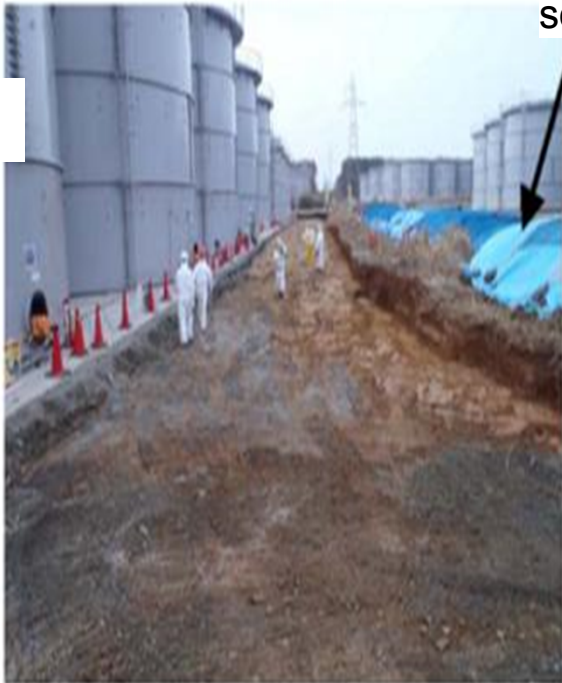
(2)

After removal of contaminated soil

Quantity collected approx. 400m<sup>3</sup>  
Surface dose after collection  
 $\gamma$  : 0.01 - 0.035mSv/h  
 $\gamma+\beta$  : 1mSv/h or lower
