Reactor imaging technology for fuel debris detection by cosmic ray muon

Measurement status report in Unit-1

March 19, 2015

Tokyo Electric Power Company

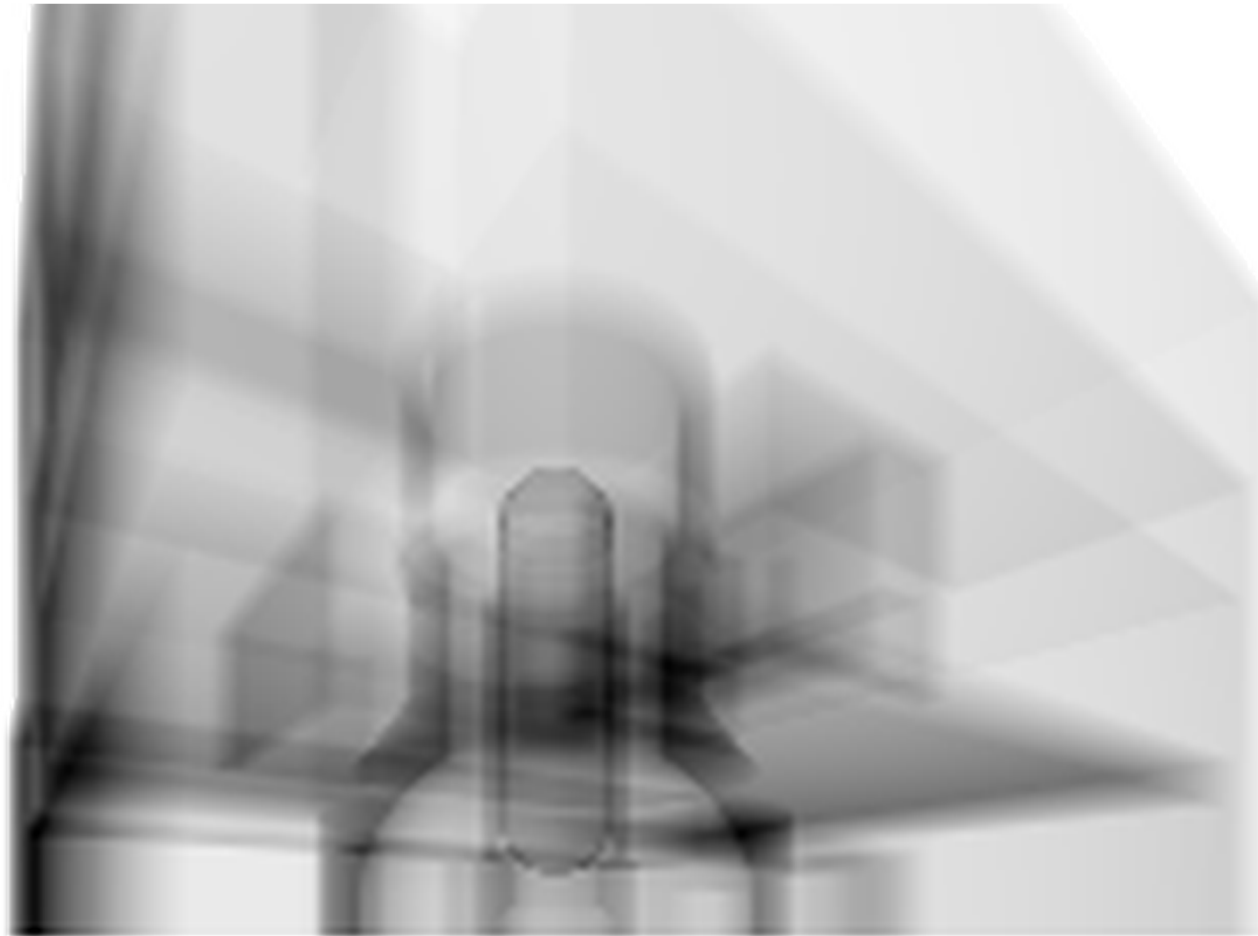
Density-length image from Detector-1 based on design drawing

When the density of substances existing inside is higher, the more muon are absorbed. The Black part inside the reactor shows reactor core location. (Assuming fuel is not damaged)

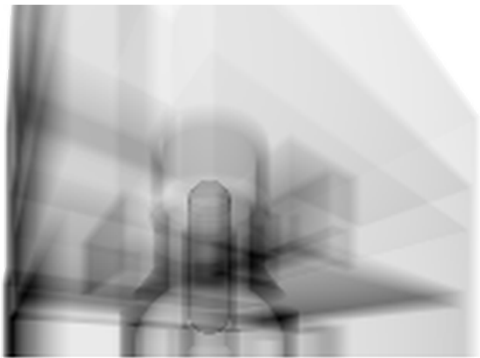
Density-length image based on design drawing

Structure edge can be identified clearly, however high-density lump can not be distinguished inside RPV

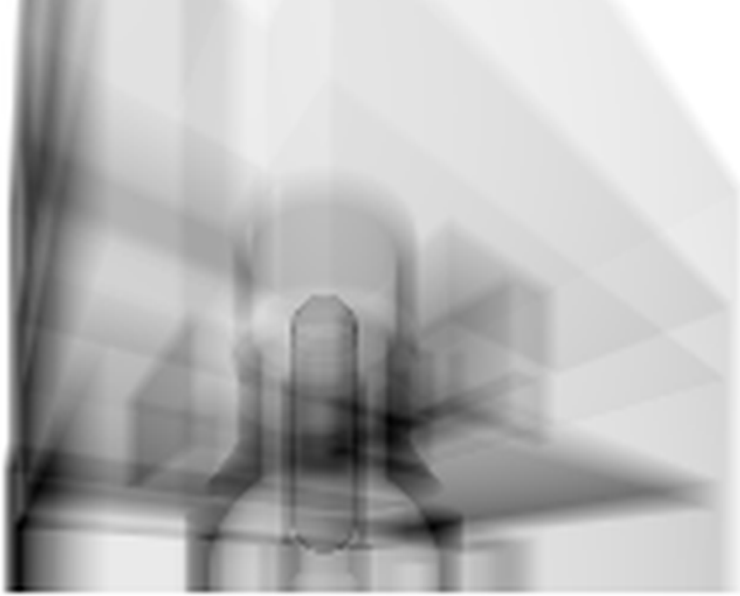
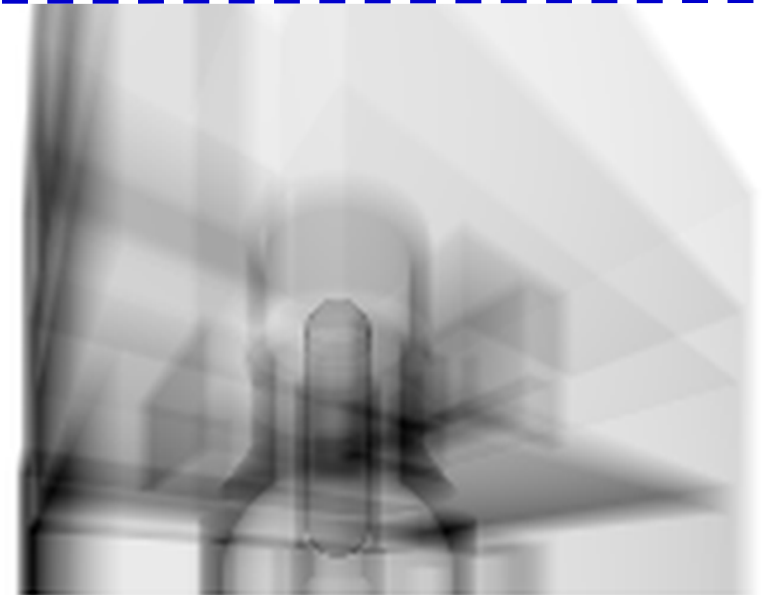
6. Qualitative estimation of debris existence by comparing image with design drawing (detector-1)

- Although the image of the measurement data is not so clear, it shows that the PCV, the RPV and the core are in positions where they should be.
- In addition, the boundaries of the PCV and RPV on the design drawings match those on the measurement data.
- However, the measurement data do not show the existence of high-density substances (fuels) in the original position of the reactor core.

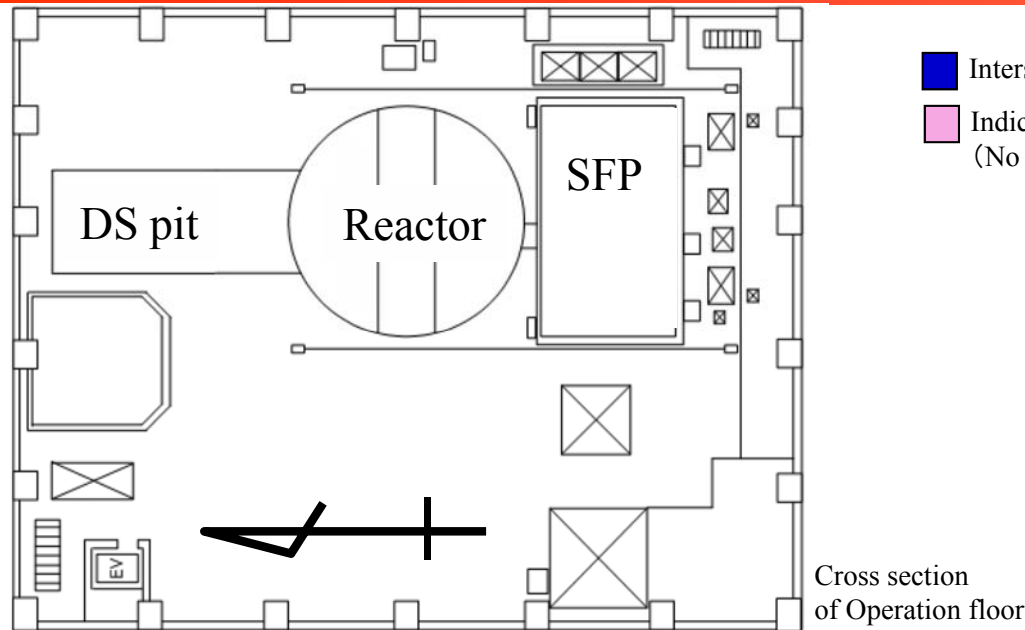
9.3D evaluation of position of high attenuation materials in cross sections

■ Intersection points by both detectors
■ Indication points by only one detector
 (No existence of high attenuation materials)

Figure 3. Evaluation of the cross section of the SFP floor
Some intersections (South side of Bldg, Corresponding to SFP)

- Through the 3D evaluation, it has been estimated that there is fuel in the SFP. (How big they are will be calculated later.)
- These results agree with the TEPCO's estimation of the current core and PCV status.
