# Fukushima Daiichi Nuclear Power Station - Causes for the reduction in the water level of the outer dike in H4 area and related countermeasures

March 19, 2015

The Tokyo Electric Power Company, Inc.

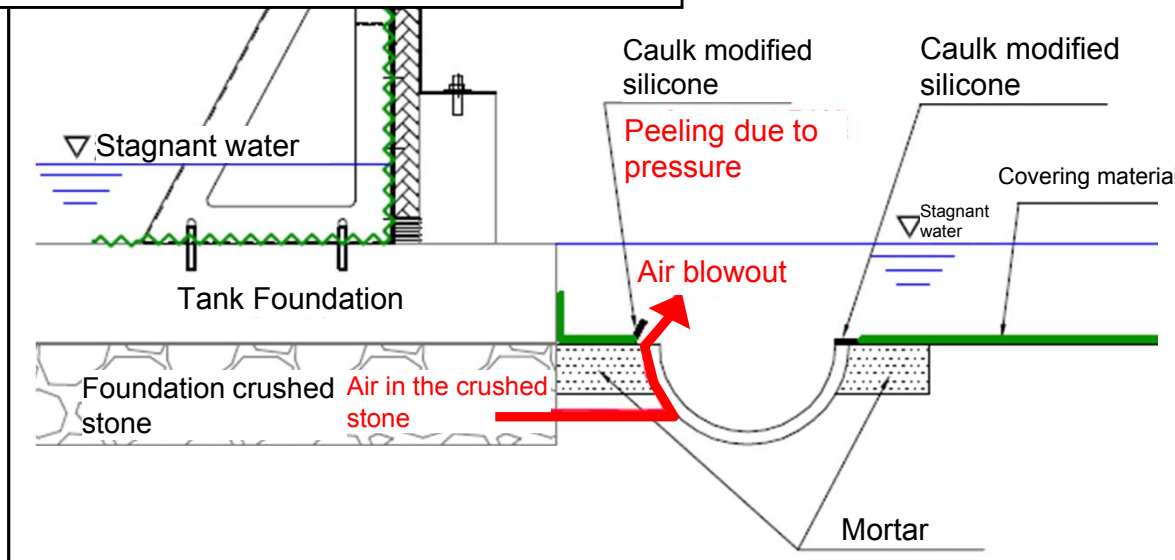
### Assumed causes of air bubbles

- Partial peeling of the covering material of the earth-fill dam was noticed at the location where there was leakage from the earth-fill dam on the east side of H4 North.
- Gaps have been formed between the gutter and the surrounding mortar on the side of the gutter on the south side of H4 and it is assumed that there is seepage into the ground from these gaps.
- Further, it is inferred that the air that is accumulated in the crushed stones beneath the tank foundation is escaping from the gaps due to which air bubbles are being forming from the side of the gutter.

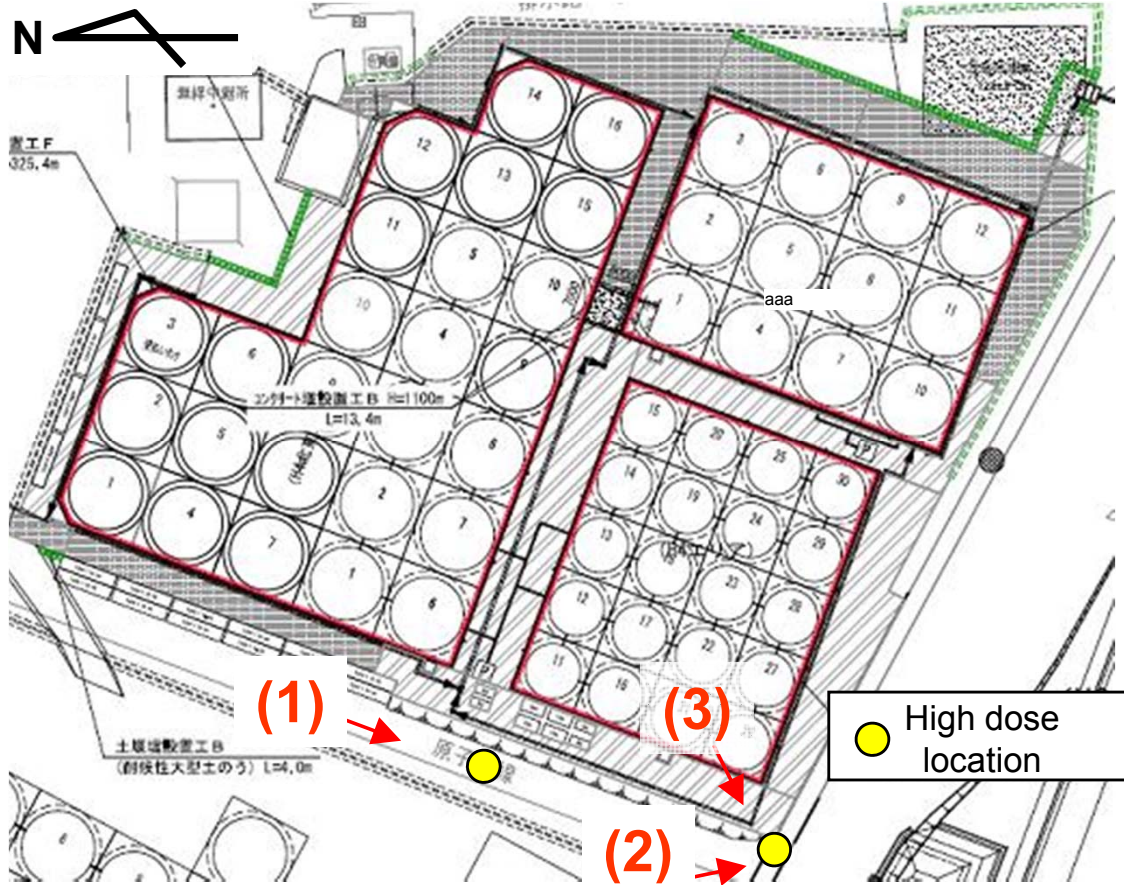
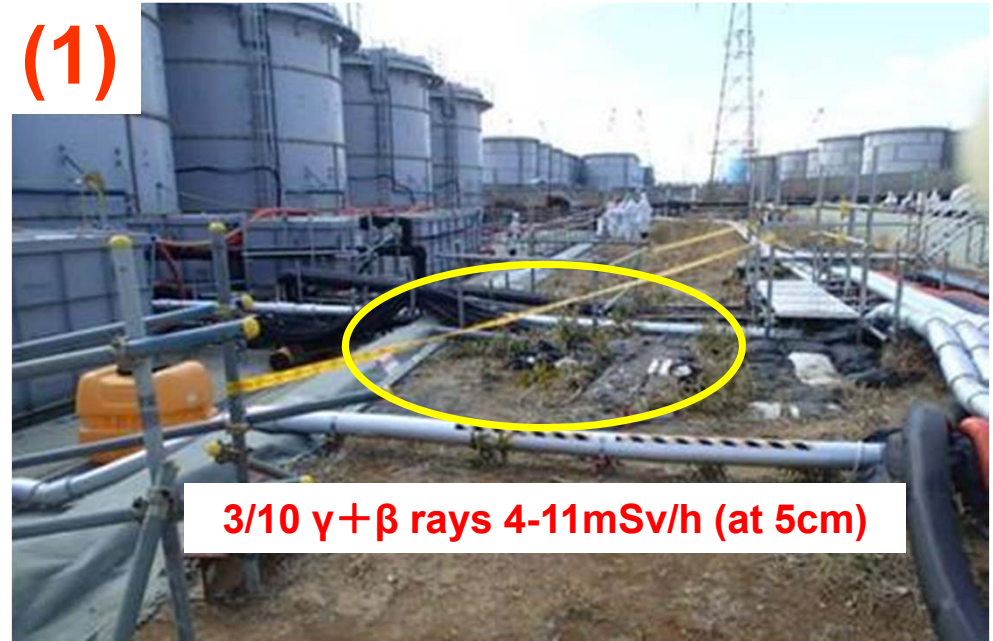
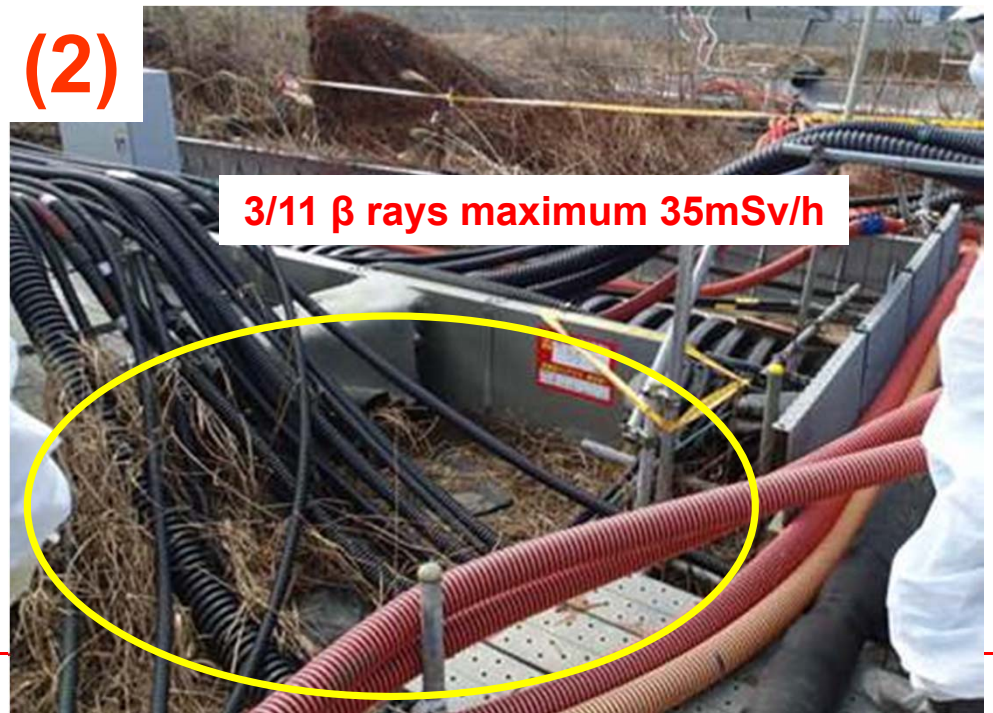
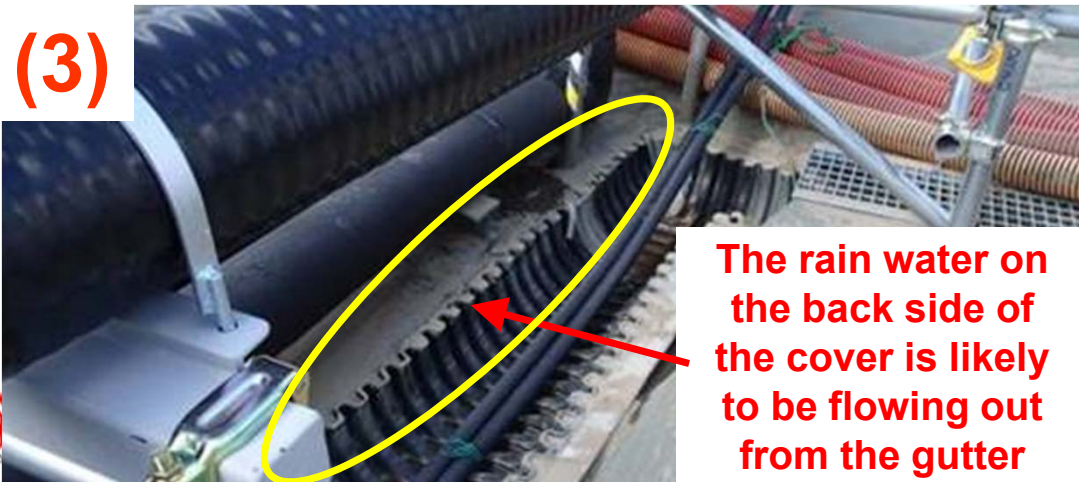
## 2. Cause Analysis (Reference: Pictures showing the condition of the high dose locations and other areas)

- It was confirmed that the high dose soil is distributed in 2 locations on the elevated area on the west side of outer dike in H4 area. These are the locations where there had been leakage from the concentrated water transfer pipe in March 2012.

- It is very likely that rain water that had come in contact with the contaminated soil during rainfall flowed into the dike via the route specified below and contaminated the water in the dike.
